Water Quality Improvement with BioSwale[®] Technology

Project Location: Reynoldsburg, OH, USA

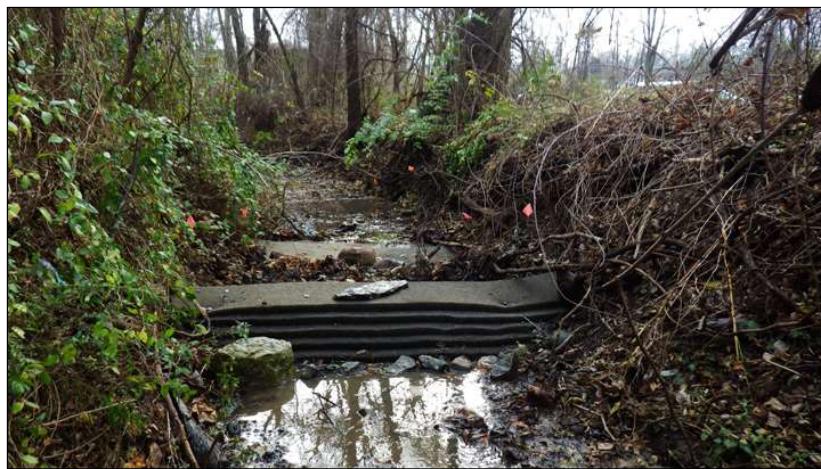
Figure 1: Typical BioSwale

BioSwales were up to ten feet wide, spanning the creek, and up to five feet long. Two of them were comprised of seven layers of 2-inch-thick BioHaven matrix for a total height of 14 inches. One was six layers high (12 inches), while two were six inches high and were installed below the water level in the deepest reaches of the creek. The three elevated BioSwales were placed approximately 50 feet apart. All the BioSwales were contained within an approximately 175-ft reach of the stream. One of the BioSwales is shown in Figure 1 and a close-up of the BioHaven matrix is shown in Figure 2. The matrix comprises non-woven, non-toxic durable fibers made from polyethylene terephthalate (PET).

BioSwales were held in place with steel nail stakes at 2-ft spacing. A cable was strung through a hole in each nail stake and attached to a duck bill anchor. Plants can be added to BioSwales but were not added initially in this study. Later efforts to add plants were largely unsuccessful, although some volunteer plants established themselves on the BioSwales.

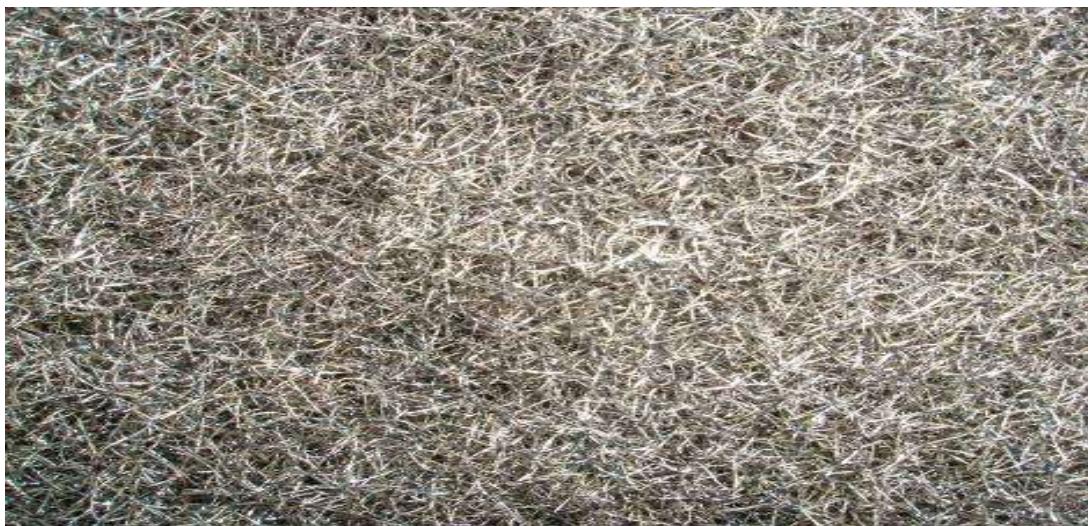
Figure 2: BioHaven Matrix

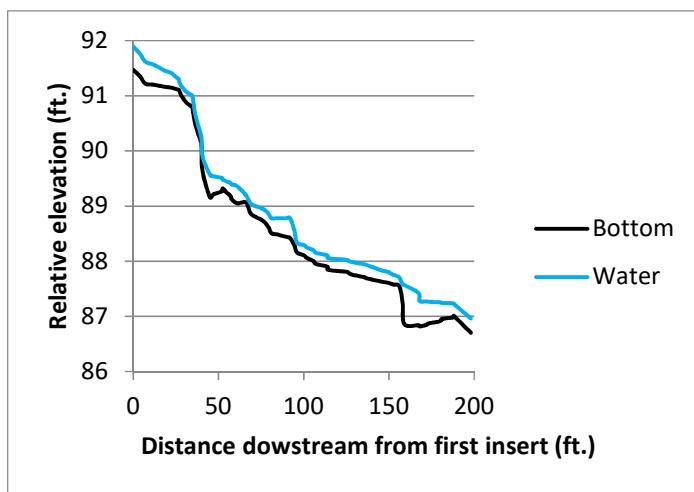
Figure 3: Stream Profile Before BioSwale Installation

In addition, stream morphology changed. BioSwailes raised the level of the streambed by one foot at the first two inserts during the first three years of the project, and the number of riffles and pools increased (Figures 3 and 4).

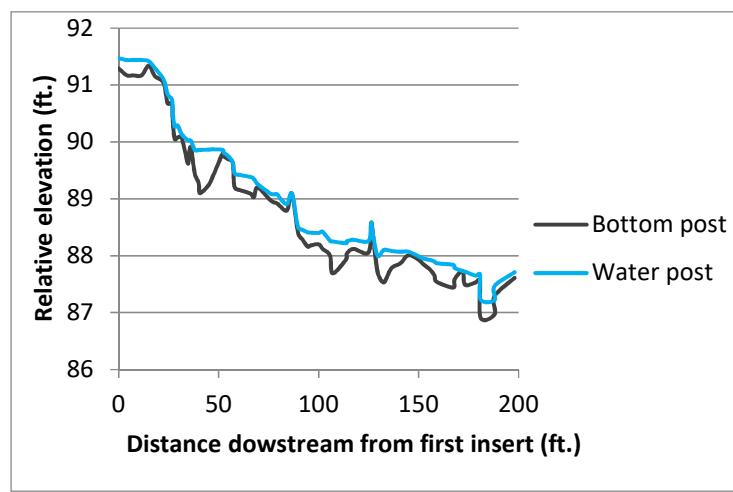
Figure 4: Stream Profile After BioSwale Installation
