Demonstrating Treatment of Landfill Leachate Using BioHaven® Technology

Project Location: McLean's Pit Landfill, Town of Greymouth, South Island, New Zealand

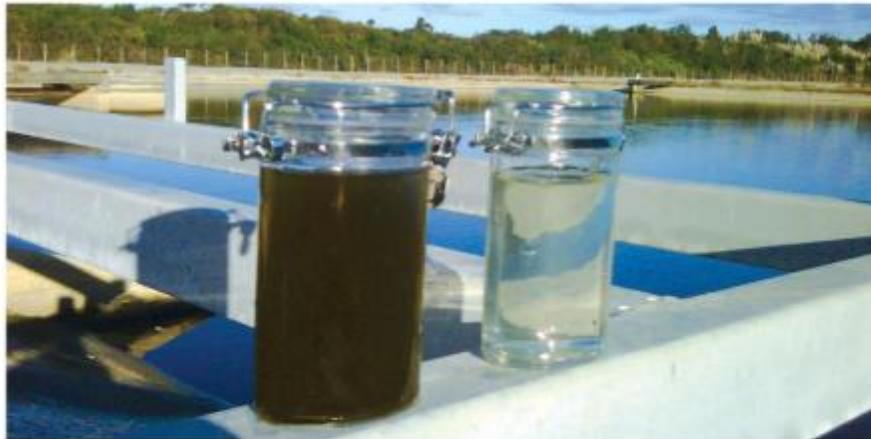
Influent (left) vs. effluent (right)

Removal of TSS and color pigment has been exceptional, as shown in the results table and first photo. The FTWs are also significantly removing total nitrogen and BOD. Operational data and detailed water quality data are still being collected and analyzed; however, the most recent data indicate that TSS removal has been improved by 89% when compared to pre-launch samples.

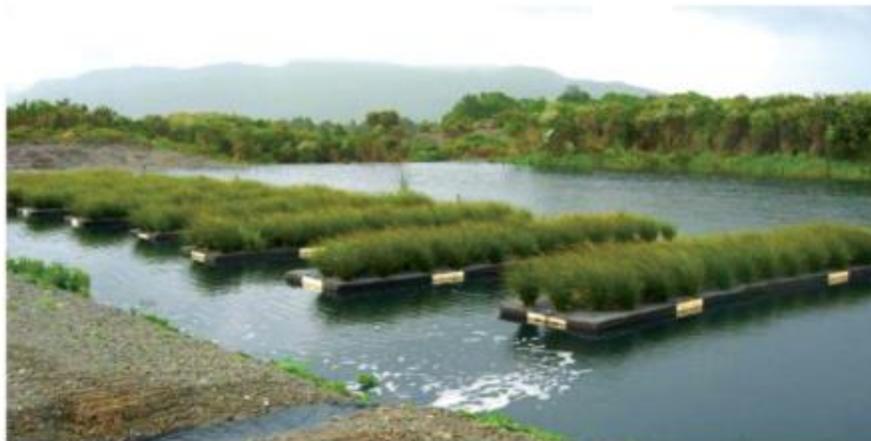
Mature FTWs in December 2009 (summer in New Zealand)

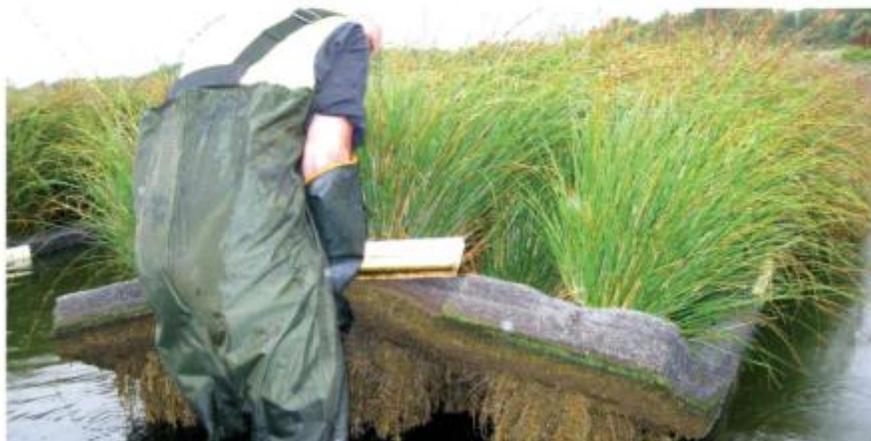
Extensive root system for nutrient uptake
